CASE STUDY

16" x 65" Furnace Tilt Cylinder

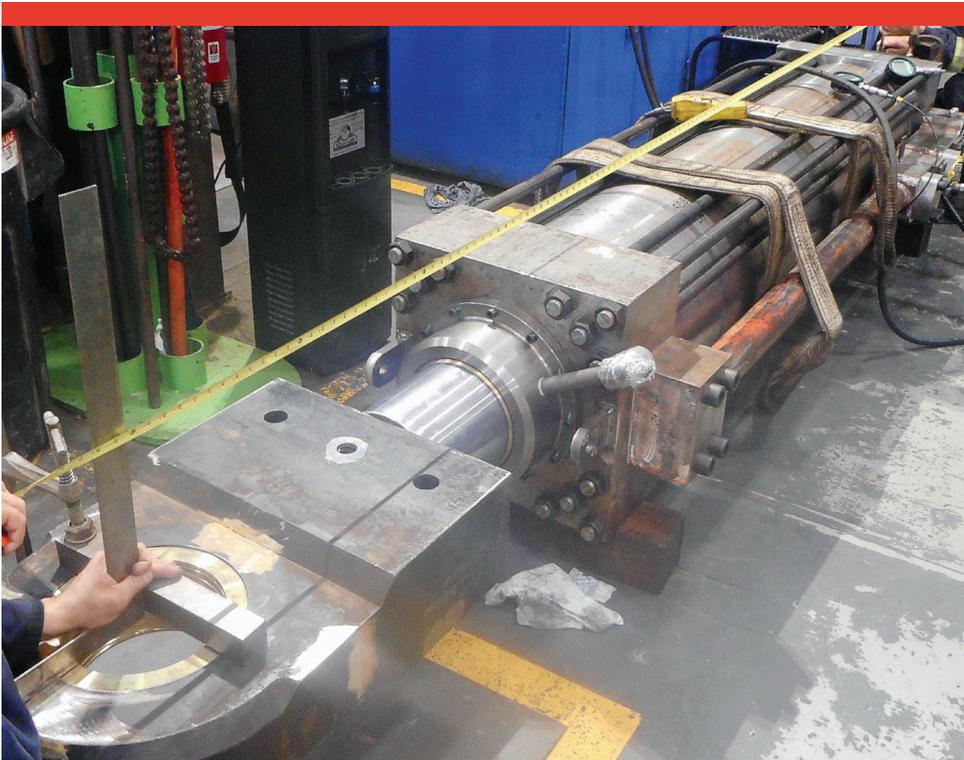
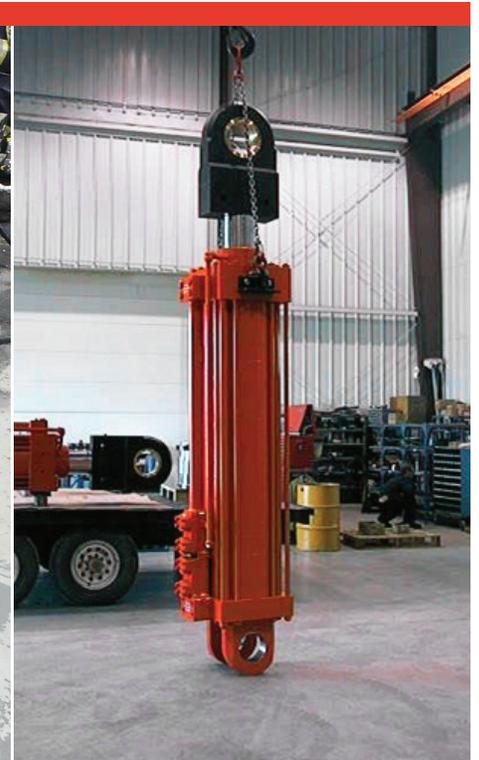
- 16" Bore, 65" stroke hydraulic cylinder
- Cylinder seized/failed resulting in a full production stoppage for the owner

- Several worn and/or damaged internal components were identified
- Provided a detailed damage report and proposal to quickly manufacture new components, meeting or exceeding the OEM specifications on a short timeline

- ✓ **Total Cost of Ownership**
Rebuilt quickly to OEM specifications, minimizing downtime and lost revenue for the facility, and at 30% of the cost of a new cylinder
- ✓ **Reliability**
Redesigned the Rod Gland to use dual seal sets with an Indicator Tube to detect primary seal failure
- ✓ **Safety**
Eliminated oil fires caused by unexpected cylinder seal failure
