PROJECT PROFILE

Bucyrus Side Frame

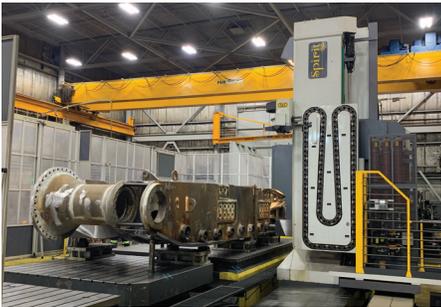
- A customer required a rebuild and upgrades on their Bucyrus 495 Electric Rope Shovel.
- The equipment had significant structural failures occurring throughout the frame, as well as excessive wear in the tumbler and roller pockets, which were impacting operational reliability.

- Brandt met with the customer for an on-site analysis to determine the scope of the repair and establish customer expectations.
- Following the comprehensive inspection, the Brandt engineers developed the detailed repair plan for the project.
- In critical wear locations, the OEM specified 4" plate was increased to 6" to provide increased strength to the frame.
- All worn, cracked, and damaged areas were welded and refurbished to OEM standards.
- Bores and bore faces in all areas were built-up and machined using our large capacity horizontal boring mill, providing superior results to conventional boring methods.
